Title		
CLOCK CONTROLLER PCB SCHEMATIC		
Size	Number	Revision
B		
Date:	1-May-2001	Sheet 2 of 4
File:	E:\PROBERTS\...CLKDIV2.SCH	Drawn By: PAUL ROBERTS

Title		
SEST MASTER CLOCK PLL		
Size	Number	Revision
B		
Date:	1-May-2001	Sheet of
File:	E:\PROBERTS\SEST\CLOCK\VCO\VCLOCK.Dwg	Drawn By: PAUL ROBERTS

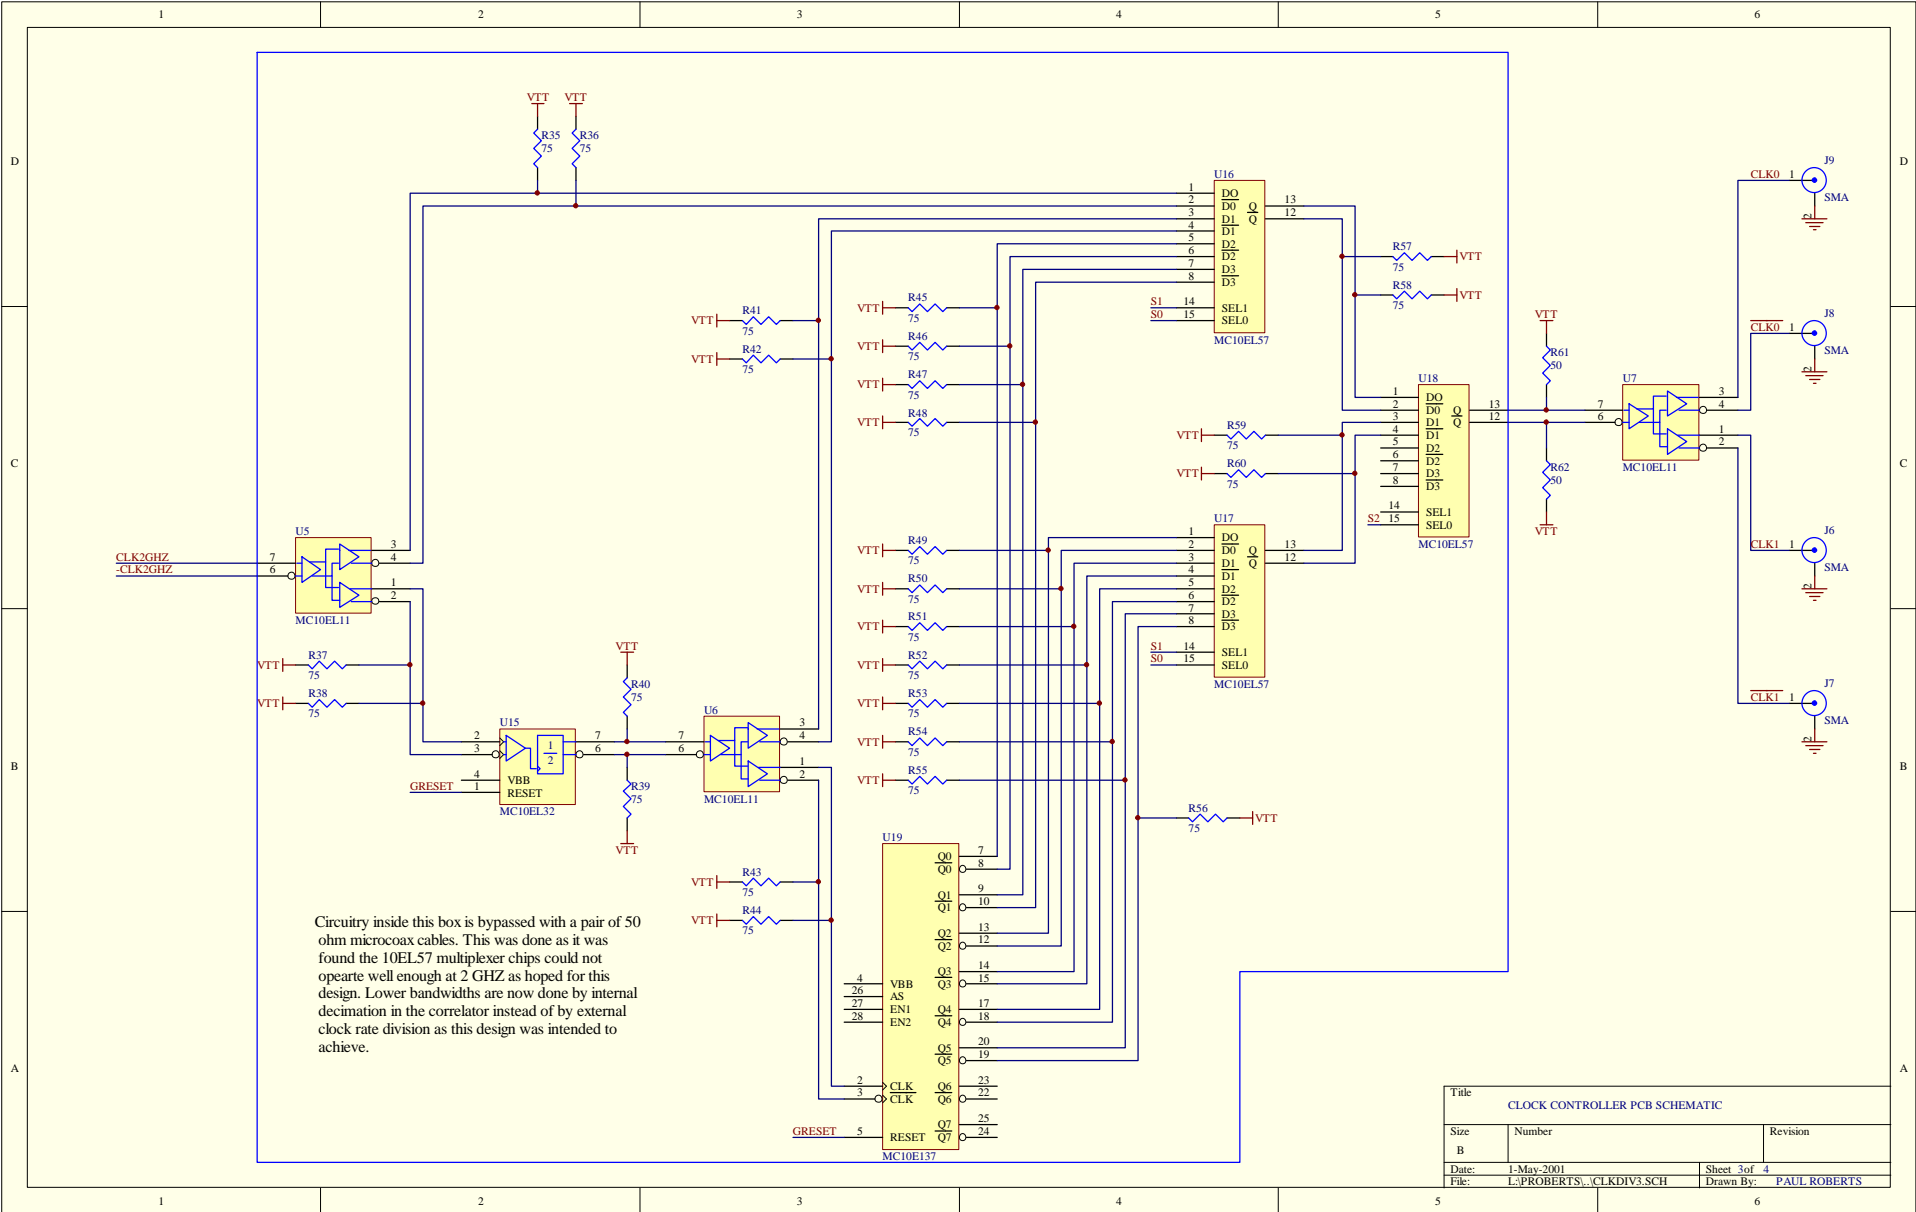
Circuitry inside this box is bypassed with a pair of 50 ohm microcoax cables. This was done as it was found the 10EL57 multiplexer chips could not operate well enough at 2 GHz as hoped for this design. Lower bandwidths are now done by internal decimation in the correlator instead of by external clock rate division as this design was intended to achieve.
